Factors Influencing Successful Mitigation of Tsunami Hazard: Lesson learned from the 2011 Tohoku Earthquake and Tsunami

Cite this as: Haerdy, R. S. M., & Fauziah, H. D. (2024). Factors Influencing Successful Mitigation of Tsunami Hazard: Lesson learned from the 2011 Tohoku Earthquake and Tsunami. TGO Journal of Education, Science and Technology, 2(2), 210–218.

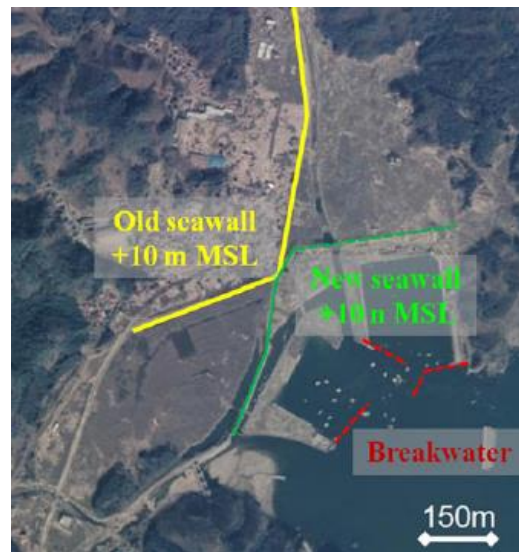
Taro City is one of the cities that uses sea walls to protect the city from tsunami disasters. Taro City is frequently affected by tsunamis. Taro City built seawalls with a height of 10 m, calculated based on the average height of sea water. The seawalls in Taro City were successful in protecting the city from the effects of the Chilean tsunami. However, in 2011, the seawalls built in Taro City did not successfully withstand the Tohoku tsunami. The tsunami surpassed the height of the seawalls, causing the destruction of the structure, and the tsunami flooded the city.

Figure 2. Seawall in Taro City
Source: (Uppasri et al., 2013)

There were three causes for the destruction of the seawalls in Taro City during the Tohoku tsunami. The first cause was the X-shape of the seawalls. This is similar to the topographical shape of the bay, which causes the tsunami energy to concentrate at one point, increasing the height of the tsunami. Another cause was that the soil around the river was not strong enough to support the seawalls. Meanwhile, high, strong currents caused scouring around the foundation and caused the seawall to collapse.

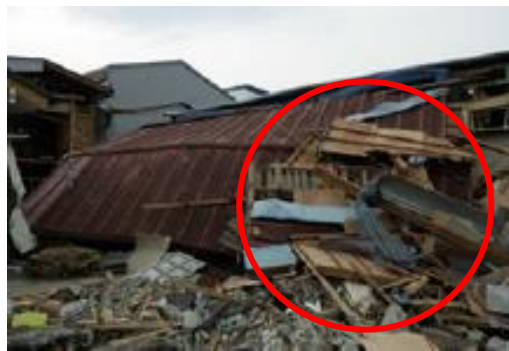
Housing Construction - Most of the housing construction in the three cities is wooden. This type of construction is very popular and sought after by the Japanese people. Wood construction is considered earthquake resistant, but it is not resistant to the hydrodynamic forces generated by tsunamis. Wooden houses are highly susceptible to being submerged and washed away by tsunamis. Wooden houses swept away by tsunamis can become floating debris that amplifies the energy of the tsunami wave as it destroys the walls of defensive structures.

Figure 3. Wooden house structures that are easily destroyed and washed away by a tsunami.

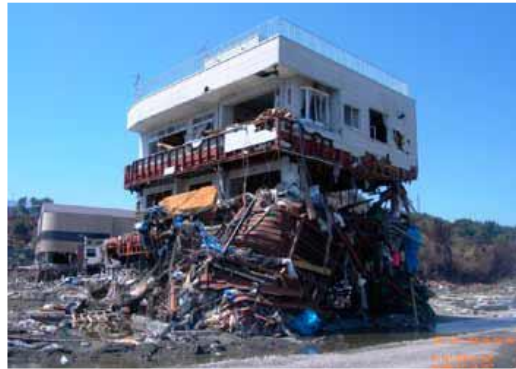
Figure 4. Floating debris trapped 3 storey building structure.
